# Manhole Inspection Summary

Manhole # S57A\_\_016MH

Insp Date: **6/25/08 10:06 AM**

**Location** Address: **201 n haven st**

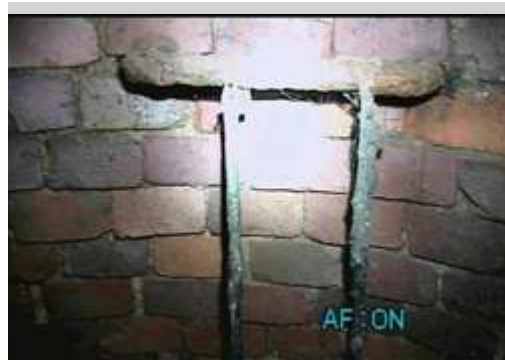
Defect 4

Condition: ☒ Sound ☐ Cracked ☐ Root Intrusion ☐ Deteriorated ☐ Leaks ☐ Debris

☒ Evidence Of Surcharge Depth: **6.** (ft.) ☐ Active Surcharge Present

bench debris

evidence of surcharge

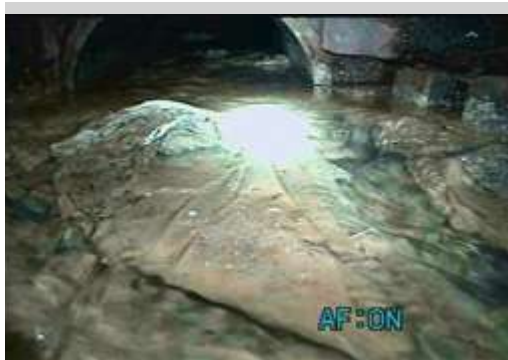
Defect 3

Condition: ☐ Sound ☐ Cracked ☐ Root Intrusion ☐ Deteriorated ☐ Leaks ☒ Debris

channel debris

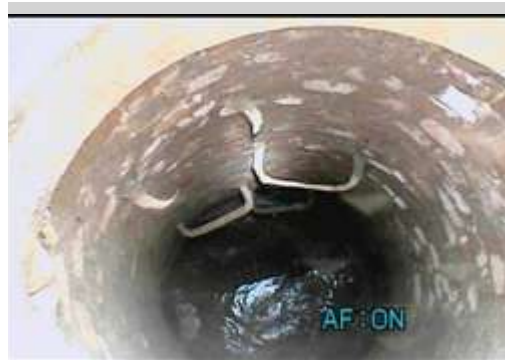
Defect 2

Count: **8** Missing: **1** ☒ Corroded

steps

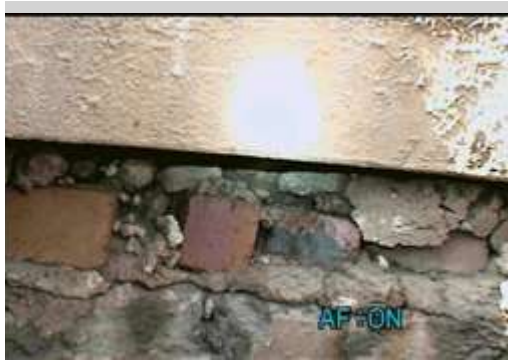
### Defect 1

Offset: **2** (in.)

Condition: ☐ Sound ☐ Cracked ☐ Root Intrusion ☒ Loose Brick ☒ Deteriorated

chimney loose bricks,deteriorated,  
frame offset

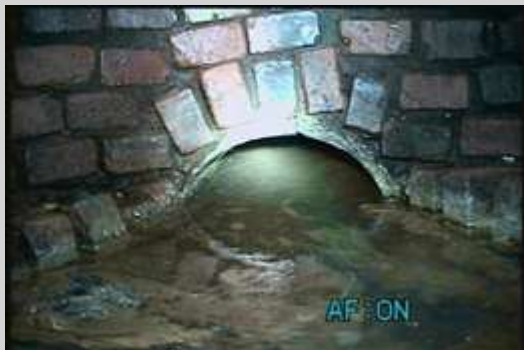
12 O'Clock Outflow

Deposits: ☐ None ☐ Mud ☐ Sludge ☒ Debris ☐ Grease

Silt Depth: 5 (in.) Deposits Extent: Heavy

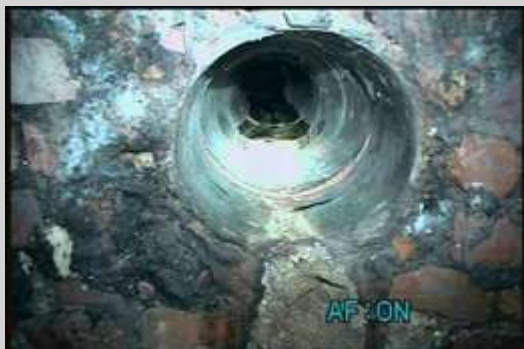
3 O'Clock Inflow

Drop: Outside Direct

Drop Condition: Clogged
